Docket No. 217 – Development and Management Plan Inspection

Northeast Utilities Service Company Certificate of Environmental Compatibility and Public Need for the construction of a 345-kV electric transmission line and reconstruction of an existing 115-kV electric transmission line between Connecticut Light and Power Company's Plumtree Substation in Bethel, through the towns of Redding, Weston, and Wilton, and to the Norwalk Substation in Norwalk, Connecticut.

Date: April 19, 2006

Location: Overhead Line (Composite 345kV and 115kV Gallows Hill to Archers Lane,
345kV H-Frame Hoyts Hill to Gallows Hill, and Norwalk Section)

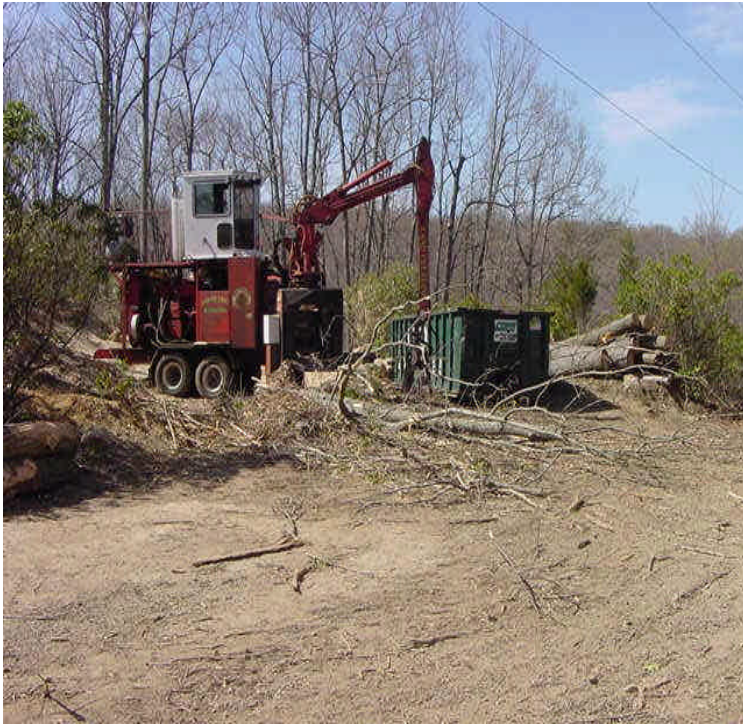
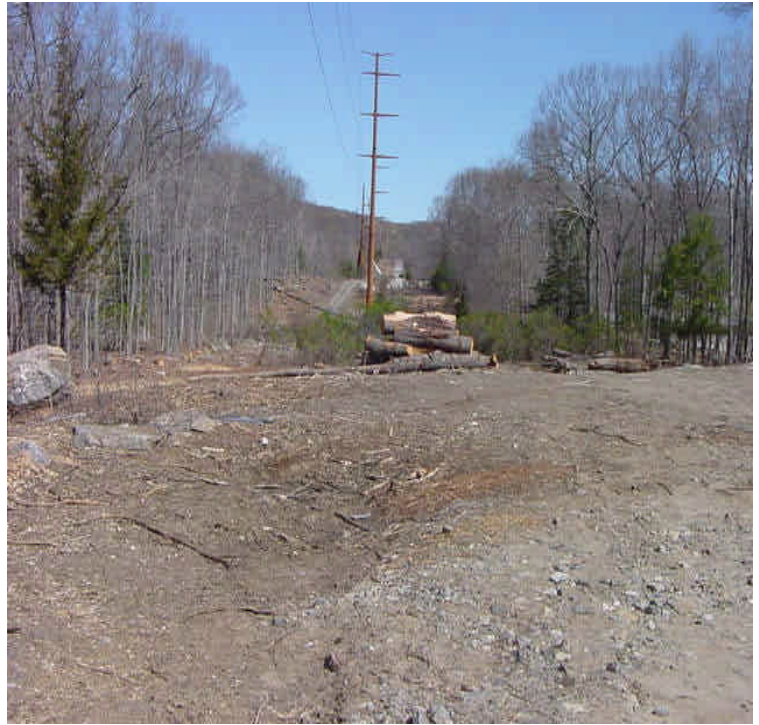
(Composite Section-Archers Lane): Photo on the left shows a view of tree clearing activities returning to the ROW past Archers Lane. Photo on the right shows a view of the ROW in this area, looking towards Rt.53. 4/19/06

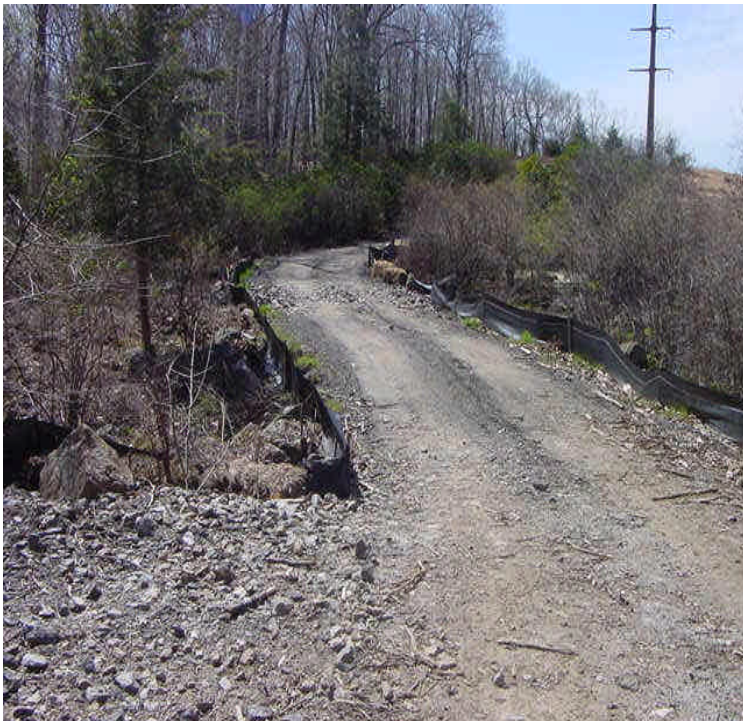
Photo on the left shows a view of the wetland crossing near Gallows Hill with controls still well in place. (345kV H-frame) Photo on the right shows a view of the ROW looking toward John Todd Way from the left pole in the Bethel Reservoir section. 4/19/06.

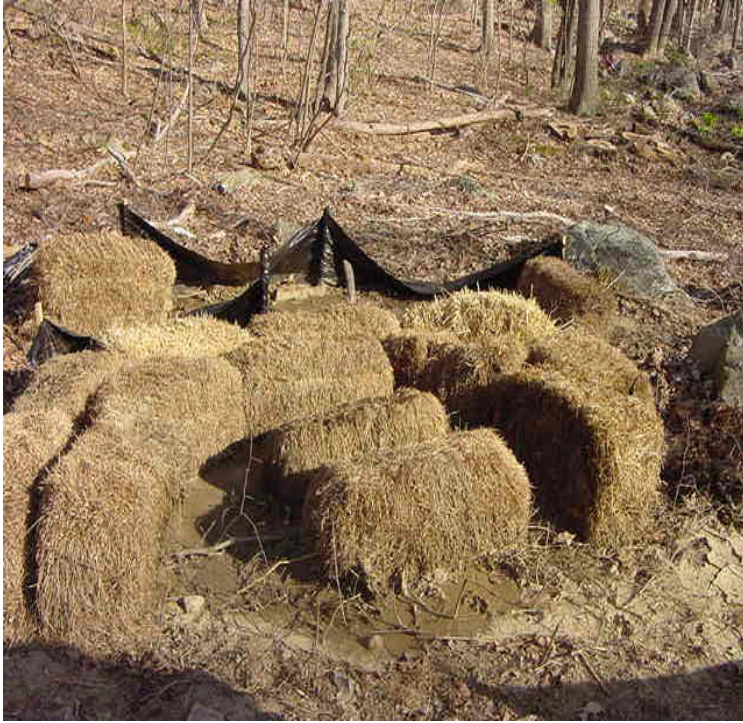
(345kV H-Frame): Photo on the left shows an area of dewatering in the Bethel Res. section. The haybales and controls worked well. Photo on the right shows a view along the ROW where a structure is being installed. 4/19/06.

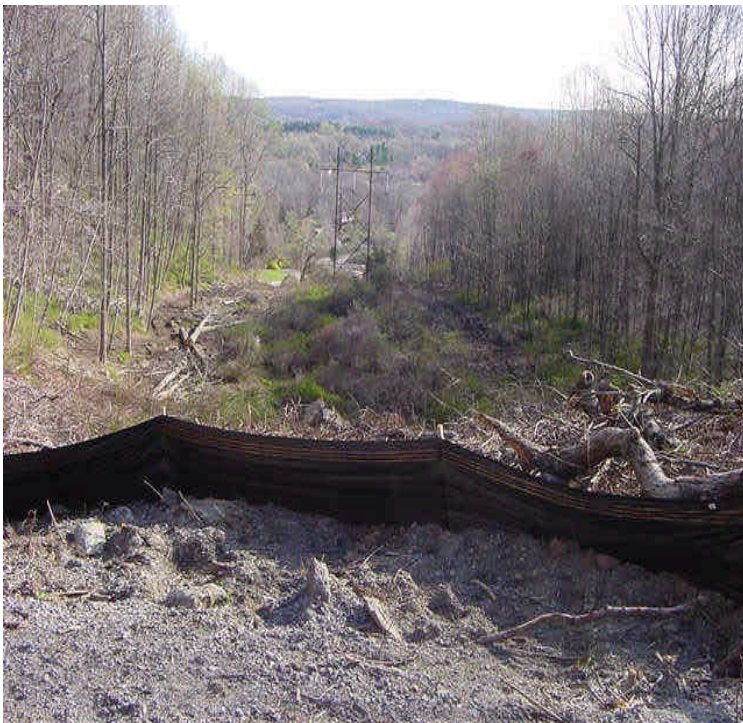
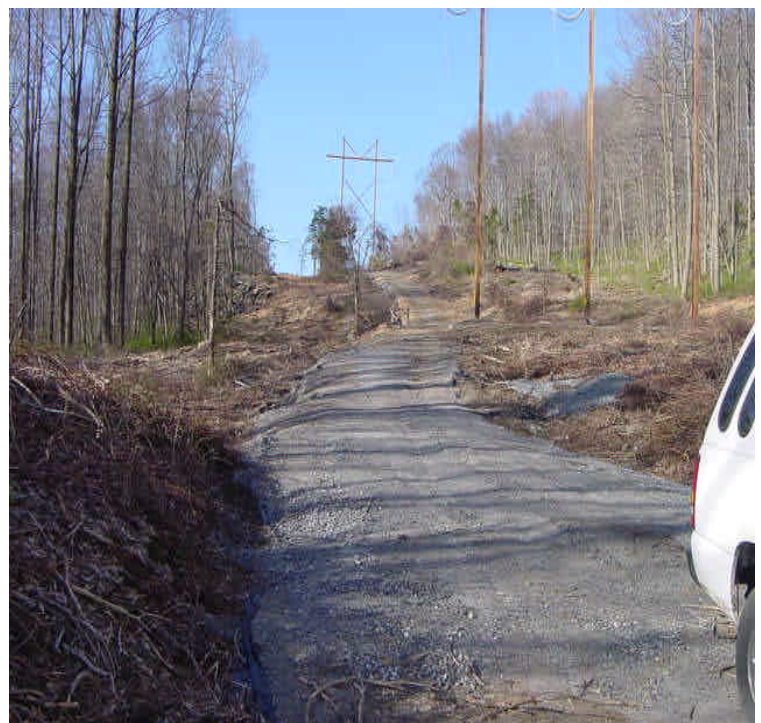
Photo on the left shows the view towards Hoyts Hill and the installation of structure #1. Photo on the right shows a view along the Chestnut Ridge section of the ROW. 4/19/06.

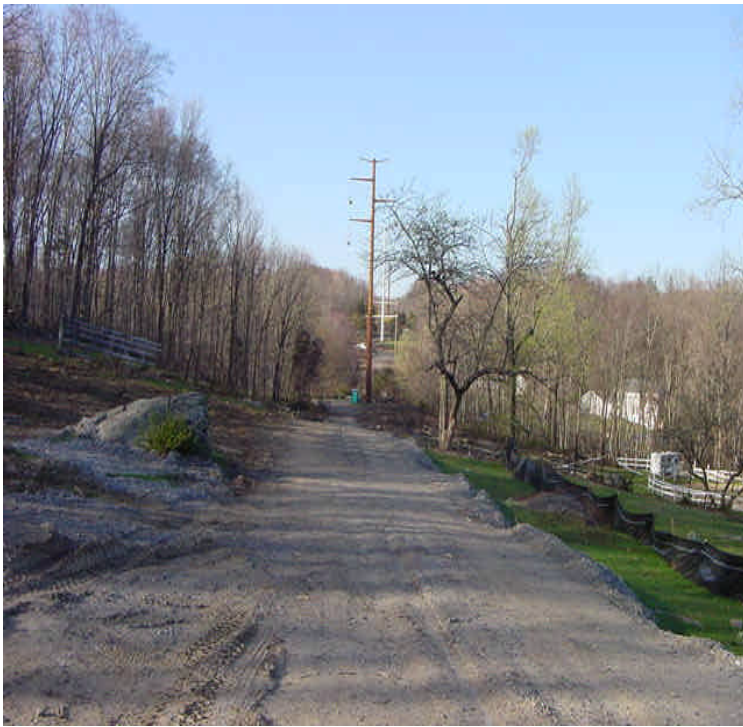
Photo on the left shows a view of the ROW looking back towards Chestnut Ridge Rd. Photo on the right shows a view of the wetlands adjacent to structures #24 and 25. Erosion controls and dewatering corrals were in good shape. 4/19/06.

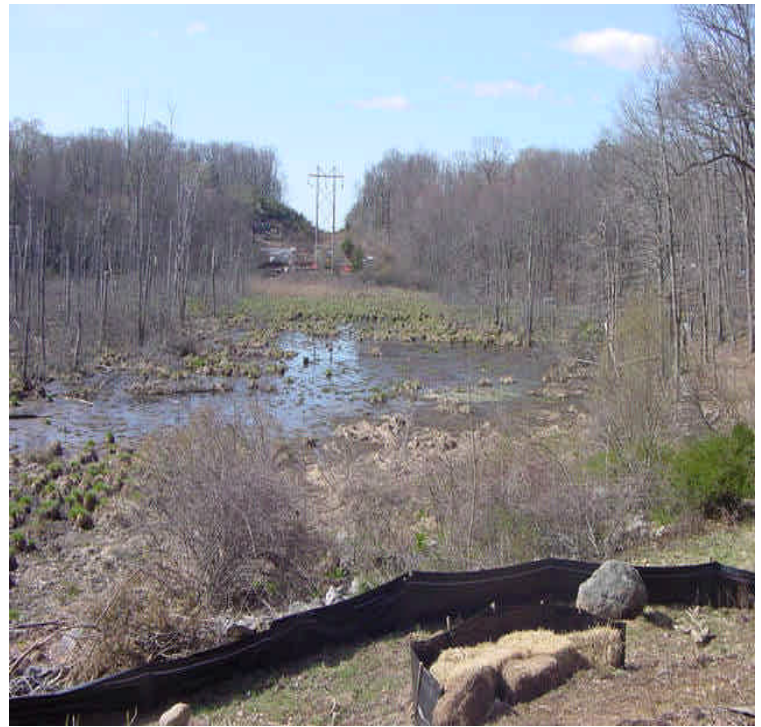
Dewatering	-Dewatering corrals had been constructed at structures 24 & 25 located off Lime Kiln Road and John Todd Way. Corrals were placed directly upgradient of the wetland areas due to topography and limited workspace. No problems with dewatering were noted during the inspection. 4/19/06.	-Monitor the dewatering activities at structures #24 and 25 in order to avoid impacting the adjacent wetland areas. If corrals are not functioning properly an alternative method, such as filter bags, will need to be used immediately in these areas.	-N/A at this time

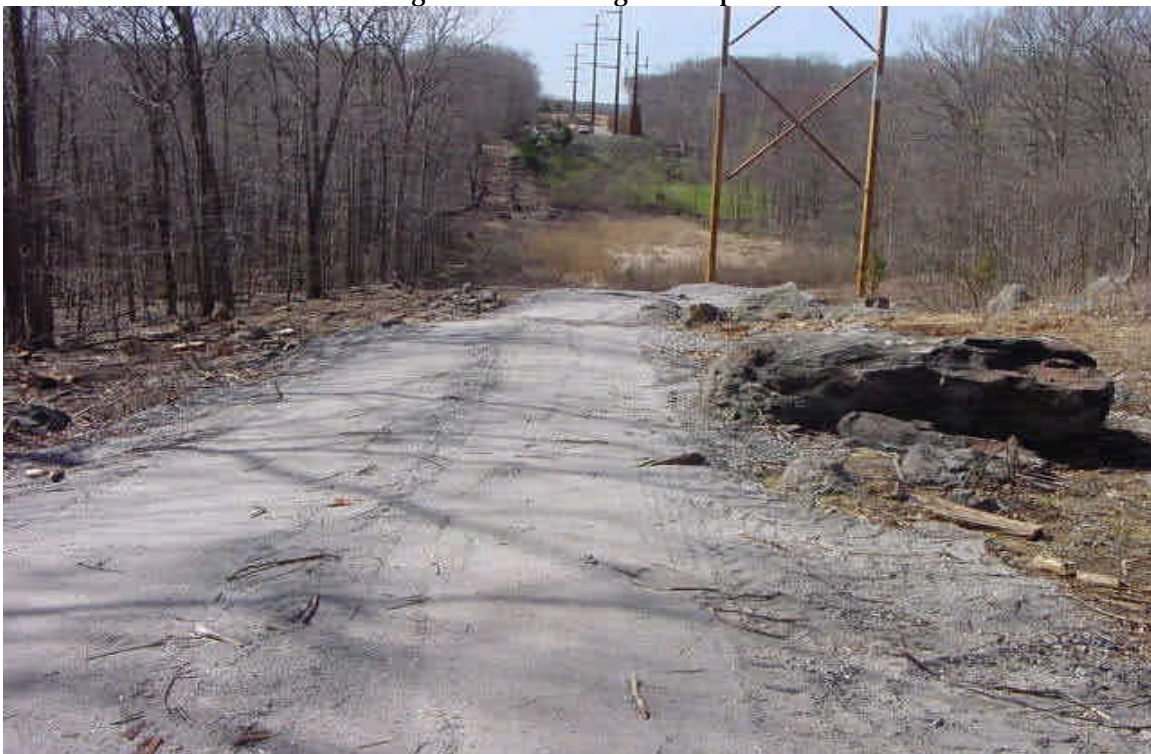
- No active work was noted in the Costa Lane section. Pole removal was noted at Limekiln. 4/19/06.	-None at this time. 4/19/06	-N/A
	-Temporary wooden rider or guard poles were being installed at roadways including Gallows Hill and Hoyts Hill. 4/19/06	-None at this time. 4/19/06	-N/A
Norwalk Section	-Foundation pouring continues to the north of Perry Ave., drilling was complete. Foundation pouring and drilling continues north of Broad St. 4/19/06.	-See dewatering and erosion controls section for more information. 4/6-4/19/06.	-N/A
	-The foundation drilling had continued in the ROW off Arrowhead Rd. (near Nwk Jctn). 4/19/06	-See dewatering and erosion controls section for more information. 4/19/06.	-N/A
Erosion and Sediment Controls	- Water levels appear to remain low at the 2 nd wetland crossing along the Archers Lane access road. 2/16-4/19/06.	- None at this time. 4/19/06.	-N/A
Composite

(345kV H-Frame Costa Lane) View of the ROW looking towards Gallows Hill. A temporary wooden rider or guard pole was being installed at the roadway. 4/19/06.

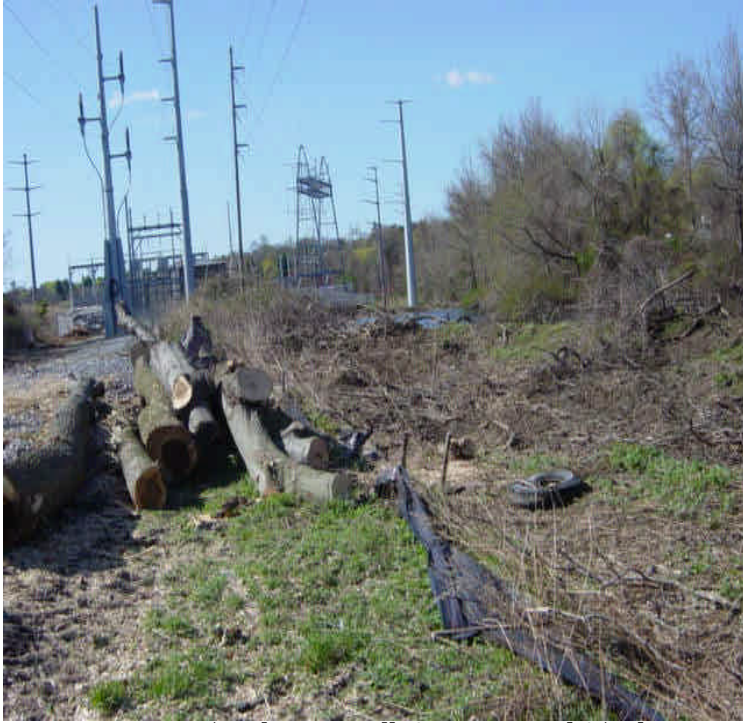
Areas of Inspection	Observation	Recommended Action	Corrective Action
	- Tree clearing south of Broad St near the substation resulted in logs down on top of the silt fence. 4/19/06	-Fence should be repaired prior to the start of work. 4/19/06	
<p>Inland Wetland and Watercourse encroachment and mitigation</p> <p>Composite</p> <p>345kV H-Frame</p>	<p>-The D&M plan approved stone on geotextile fabric at the wetland crossings have worked well. Efforts were made near Archers Lane to start removing some accumulated sediment. 4/6-4/19/06.</p> <p>- Direct damage was noted in the wetland at the 3rd crossing as a result of equipment slipping. 2/16-4/19/06.</p> <p>- The 1st wetland crossing has the most noticeable sediment deposits and this needs to be removed. 4/6-4/19/06.</p> <p>- Use caution in clearing trees from wetland areas. Avoid creating ruts when skidding them out. 3/29-4/19/06.</p> <p>- Use caution in removing trees from wetland areas or adjacent to streams in this section as well. Avoid creating ruts when skidding them out. 1/19-4/19/06.</p> <p>-If a wetland is being used as amphibian breeding habitat, retaining some wood debris at its boundaries may be beneficial. 3/2-4/19/06.</p> <p>- At structure #6, most of the mud was removed</p>	<p>- As the access is considered temporary, the stone will be removed when final work ends so the wetlands can be restored. 1/26-4/19/06.</p> <p>- The damage to the 3rd wetland should be repaired. 4/19/06.</p> <p>- The crossing could also use some clean stone if necessary which may help reduce additional sediment deposits. 1/4-4/6-4/19/06.</p> <p>- Retain shrubs and low growth as much as possible. 3/2-4/19/06.</p> <p>- If damage is noted during the spring, the previously created ruts should be repaired if possible. 3/9/06-4/19/06.</p> <p>- Try to leave shrubs and low growth where possible, especially at stream buffers. 2/2-4/19/06.</p> <p>-Carefully remove brush piles and trees from near wetland areas. 3/2-4/12/06.</p> <p>- Continue to remove entire pile. Conditions</p>	<p>-N/A until evaluated at the end of work.</p> <p>-Efforts to retain lower growth have been noted in this section.</p>

(345kV Norwalk Section Broad St) Photo on the left shows some additional clearing along Broad St. Silt fence had come down further due to the clearing. Photo on the right shows clearing occurring to the north of Broad St. 4/19/06

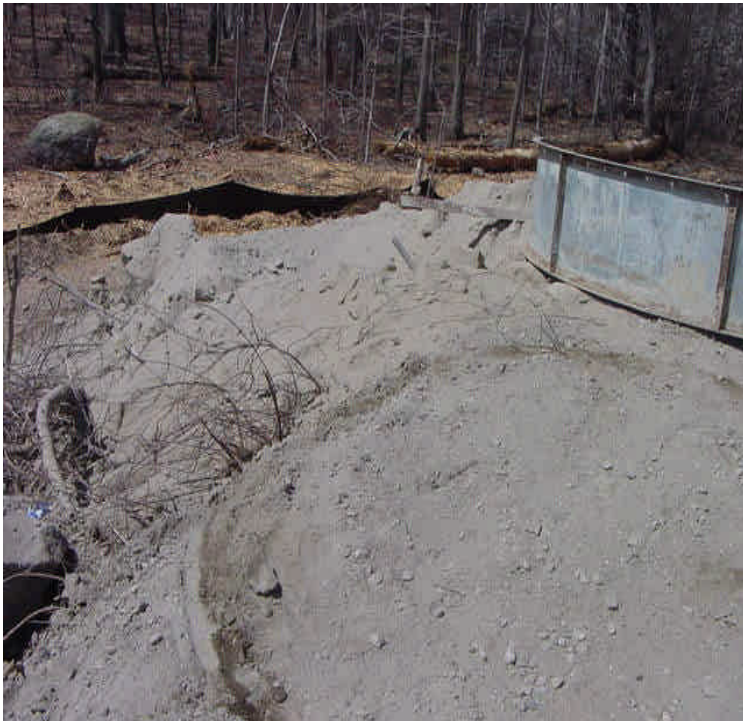
- Silt fence remains in good repair at foundations south of Perry Ave. 4/6-4/19/06.	-Continue to maintain the silt fence in this area and utilize it as a limit of work due to the proximity of the channel. 4/19/06.	-N/A.
	-Silt fence remains at the foundation drilling north of Perry Ave near Rt.7 4/19/06.	-None at this time. The fence prevented migration of dust from drilling 4/19/06.	-N/A

North of Perry Ave: Photo on the left shows where silt fence was installed to prevent migration of stone dust and sediment from the foundation drilling. Arrowhead Rd.: Photo on the right shows where dewatering discharge from the foundation has accumulated along the silt fence. 4/19/06

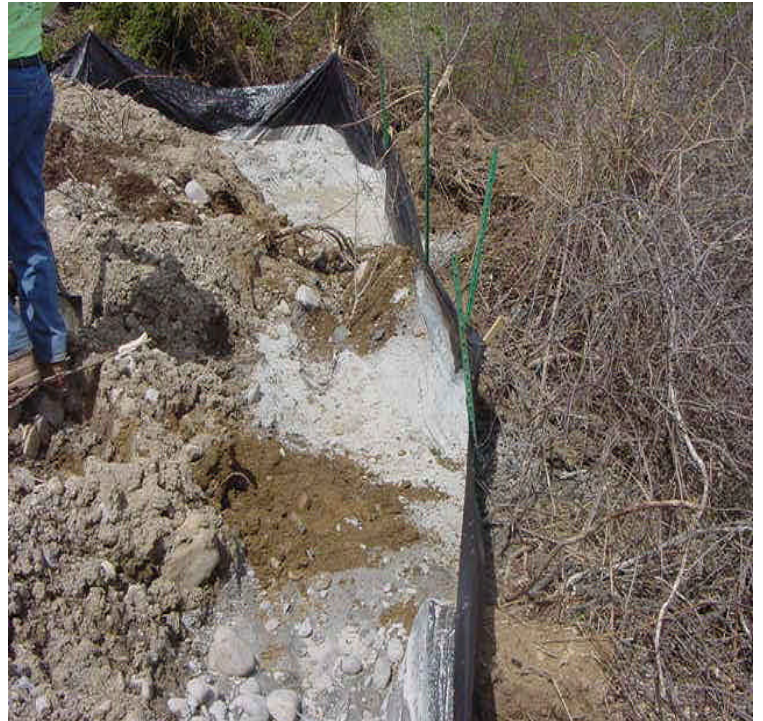
- Several spots of concrete were removed as recommended. 4/19/06	- None at this time. 4/19/06	Concrete was removed.
	-The foundation drilling off Arrowhead Rd. required dewatering and slurry mix. Small washouts were noted at the slit fence. 4/19/06	- Repairs were made during the inspection and haybales were recommended for further stabilization. 4/19/06	-Repairs were made at the time of inspection

Areas of Inspection	Observation	Recommended Action	Corrective Action
	-Dewatering at the structure off Arrowhead Rd. led to some washouts of the silt fence. 4/19/06.	3/9-4/6/06. -Repairs were made immediately. 4/19/06	-Repairs were made.
Blasting	-No blasting has been necessary at this time on the ROW. 4/19/06.	-None at this time. 4/19/06.	-N/A
Spills and Material Storage	-None of the parked or active equipment was leaking at the time of inspection. 3/15-4/19/06.	- Continue to keep all vehicles maintained well (i.e. no apparent fluid leaks) if they will be used or stored on site - Keep adequately size fuel kits for worst case scenarios. - Report spills immediately, even if they are being controlled. - Avoid refueling in the areas near the wetlands. Use proper storage for all materials.	-N/A
Additional Observations
